1.0 Introduction

On the 12th – 24th 2011 a close visual inspection of external, roof areas, including and not limited to

STONE TECHNICAL SERVICES	
<i>Client:</i> Newcastle City Council	
<i>Site:</i> City Hall	
Roof Survey	Not To Scale

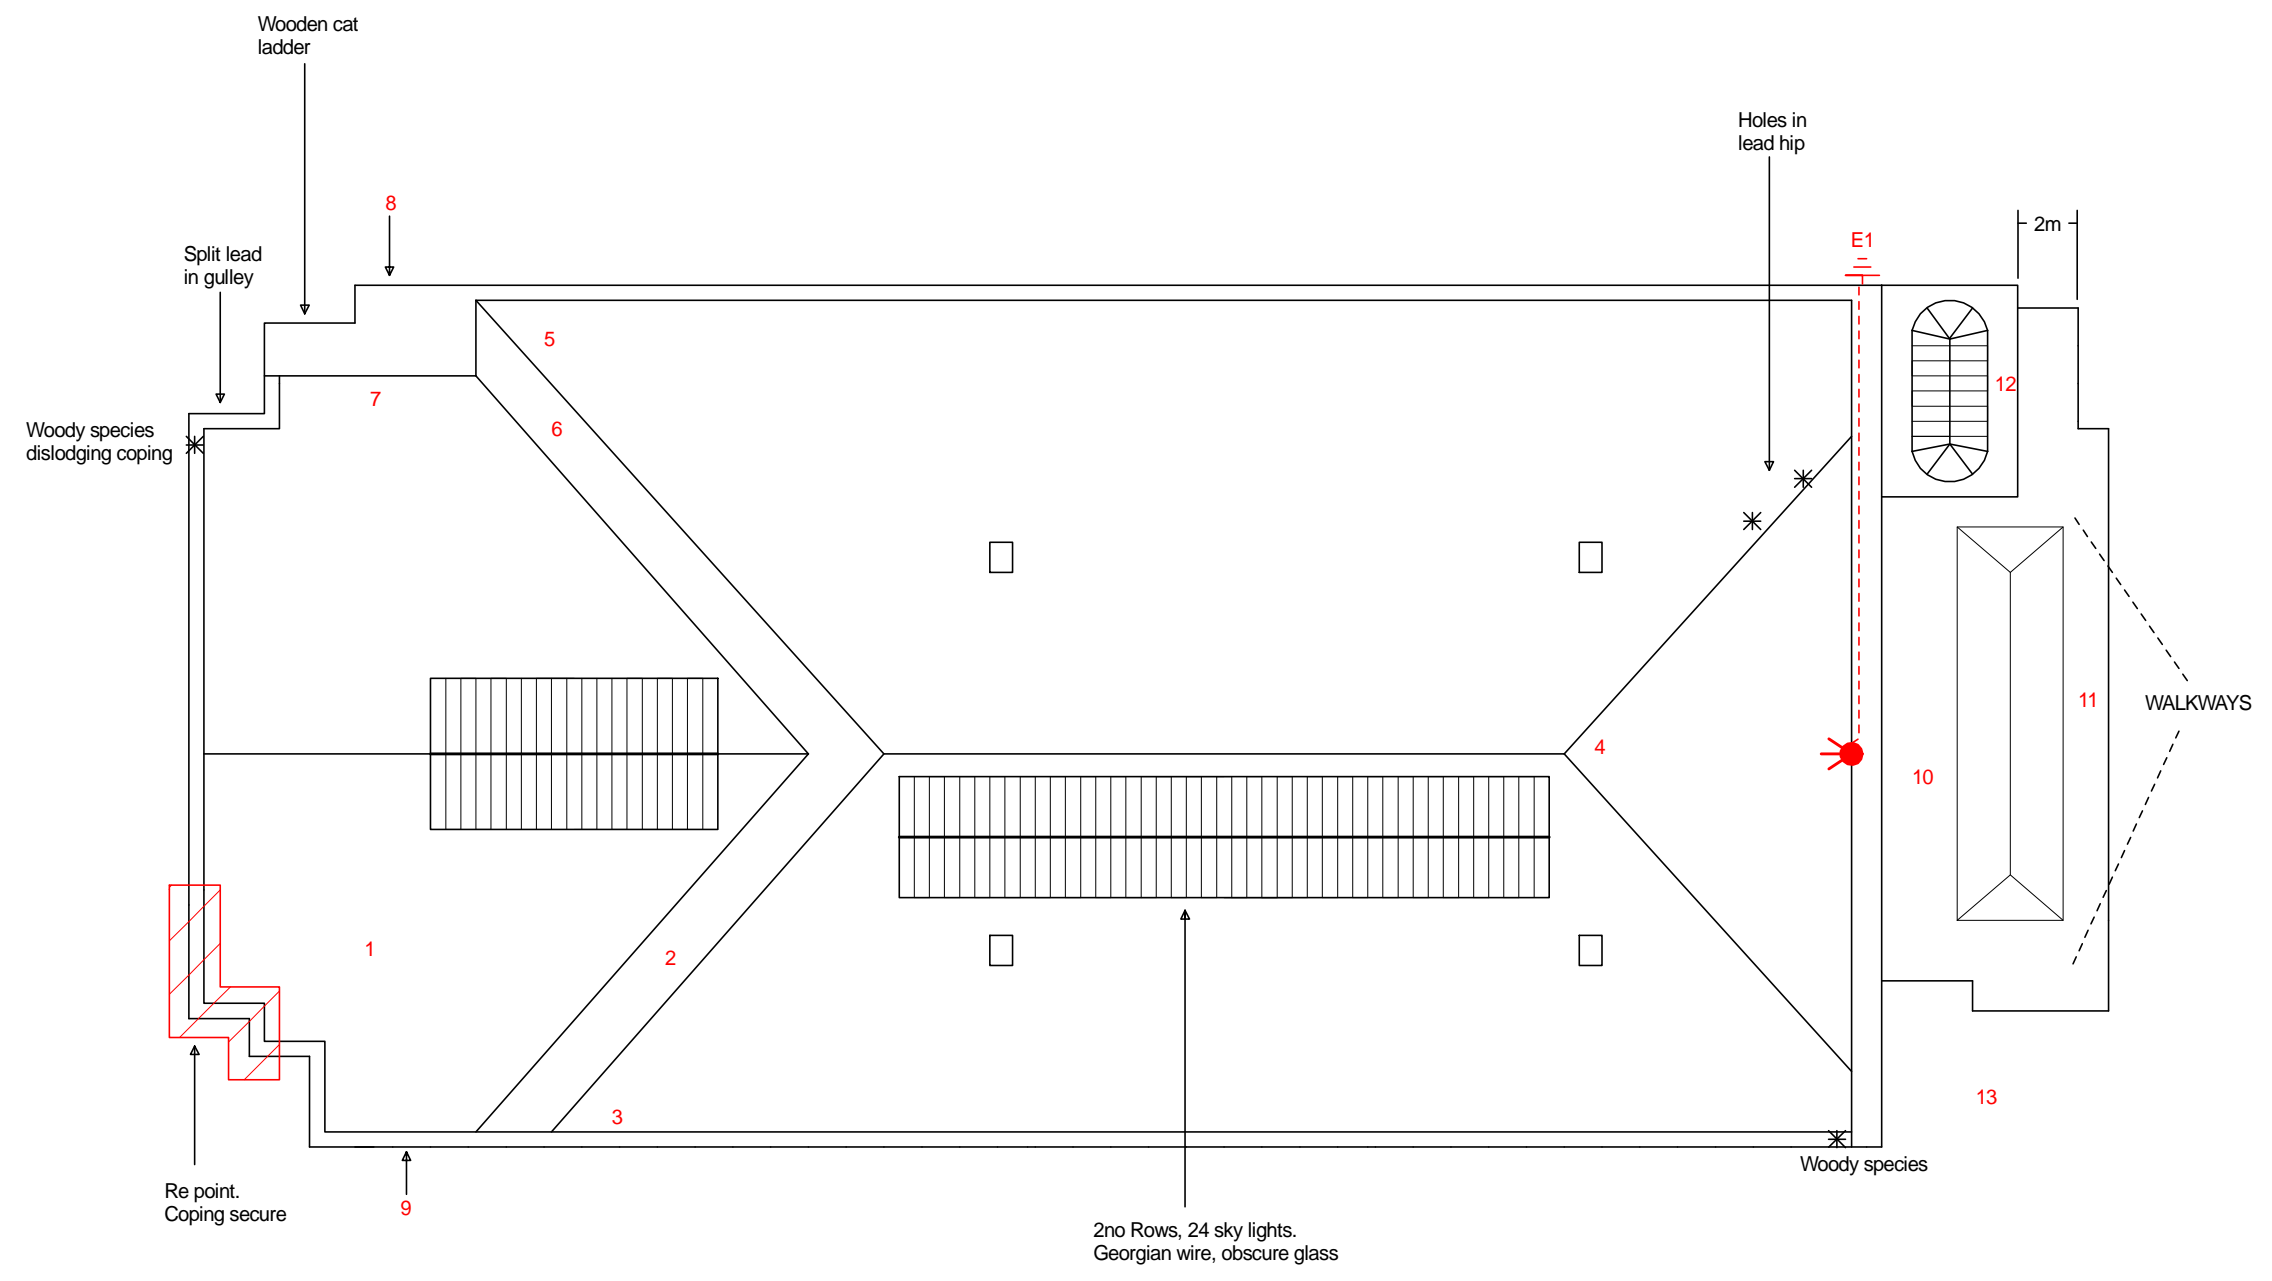
Section marked 3 on drawing shows expanded iron glazing bars, deformed and misaligned, this has been reported a number of years ago, internal netting was installed as a short term solution to possible collapse, this area is of concern our report of the @@@@ is attached.

Lightning protection

Upgrade present system to BSEN:62305. System is long standing and inadequate for a public building, we can provide a risk assessment to BSEN:62305 upon request.

System requires additional down conductors, and air terminal I, and addition earthing to BS7430.
