PROJECT:	ST PAUL'S CATHEDRAL
DRAWING TITLE:	ROOF PHOTOGRAPH AND LOCATIONS
SCALE:	NOT TO SCALE @ A1
DRAWN BY:	J LEWIS
DATE:	JANUARY 2013
DRAWING NO:	001
REVISION:	-

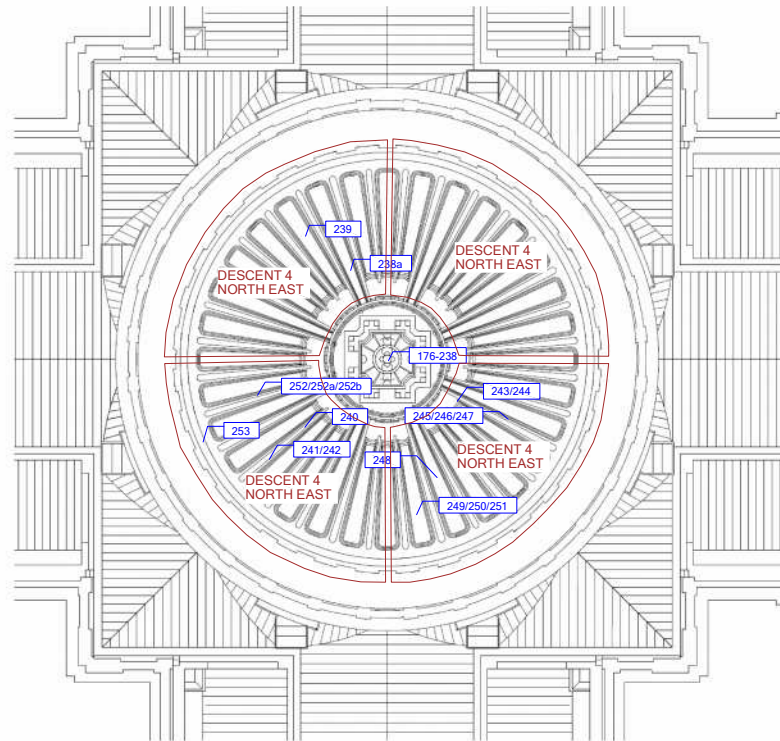
245. Descent 3 loose copper cleat SE downtape Descent 3
