INTRODUCTION

- 1.1 Stone Technical Services Ltd was commissioned by Geoffrey Osborne Limited to undertake a structural inspection survey of the Lighting Towers 6 & 7, Wimbledon Train Depot, London. This report was instigated by the client in order to ascertain whether the two aforementioned lighting towers were in sufficiently good condition to be accessed for the purpose of their demolition. Unlike the other lighting towers on the site these two towers are located in positions which present access difficulties for large cranes etc. As a consequence the client is planning to dismantle the towers in small sections which requires a person to access the towers in order to assist with the dismantling of the structure.

3.1 Lighting Tower 6 - (Approx. 30m in height) (See Appendix A for survey photos)

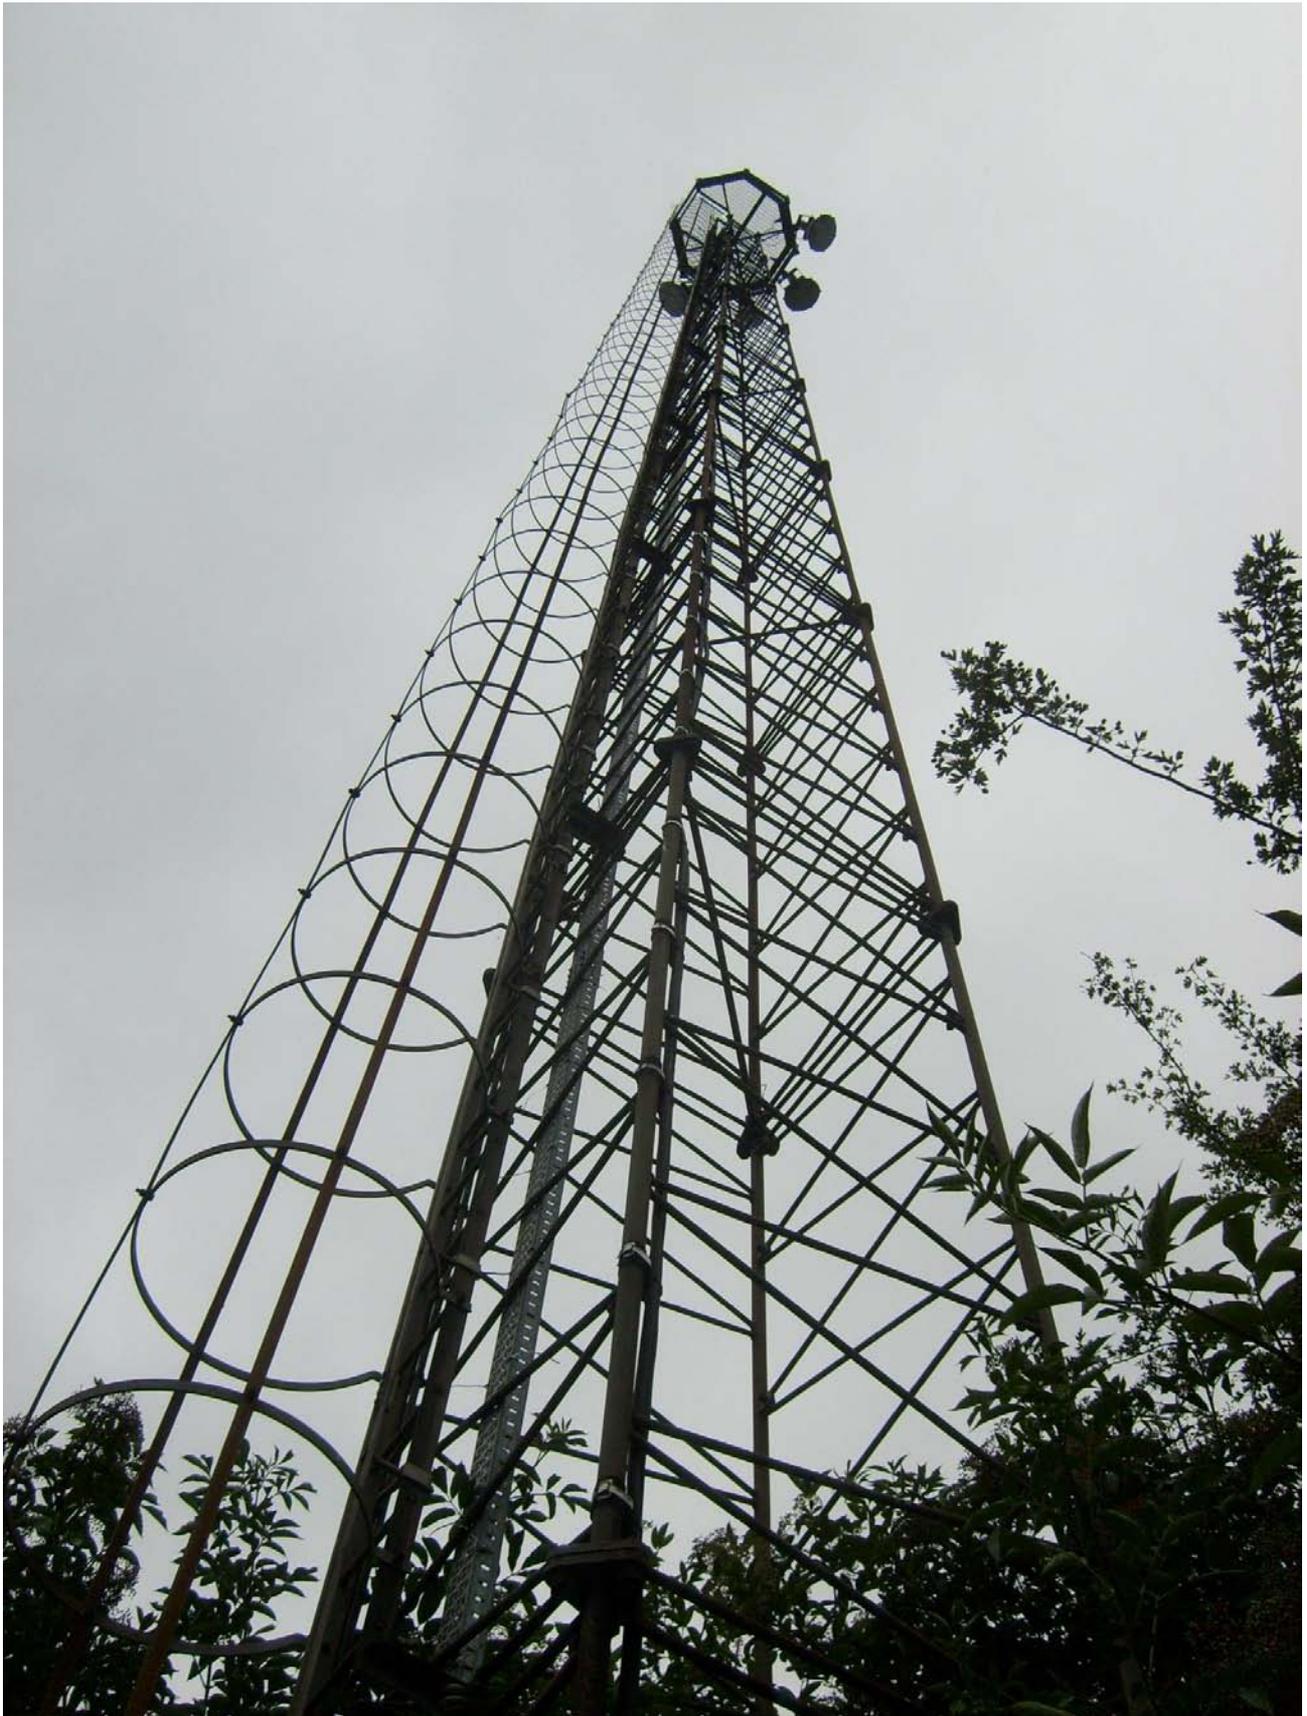
APPENDIX A - SURVEY PHOTOS

- 3.1.3 The structural members displayed increasing amounts of rust the higher up the tower they were located although even those members possessing the greatest amounts of rust had not suffered a significant loss of cross sectional area. Photo 11 of tower 6 shows a typical example of the level of rusting observed at the higher levels of the tower. When touched the rust was not found to be flaky and the surface of the members felt hard to the touch. The level of rust observed on the tower was therefore considered insignificant in terms of the structural adequacy of the tower especially in light of the fact that they are due for demolition shortly. If, however, it was decided that the towers were to be retained then it would be recommended that the rust be cleaned from all members and that they be painted for protection against further loss of cross sectional area.
