St. Paul's Cathedral – Dome & Gilded Cross Assembly: Accessed Survey

Report

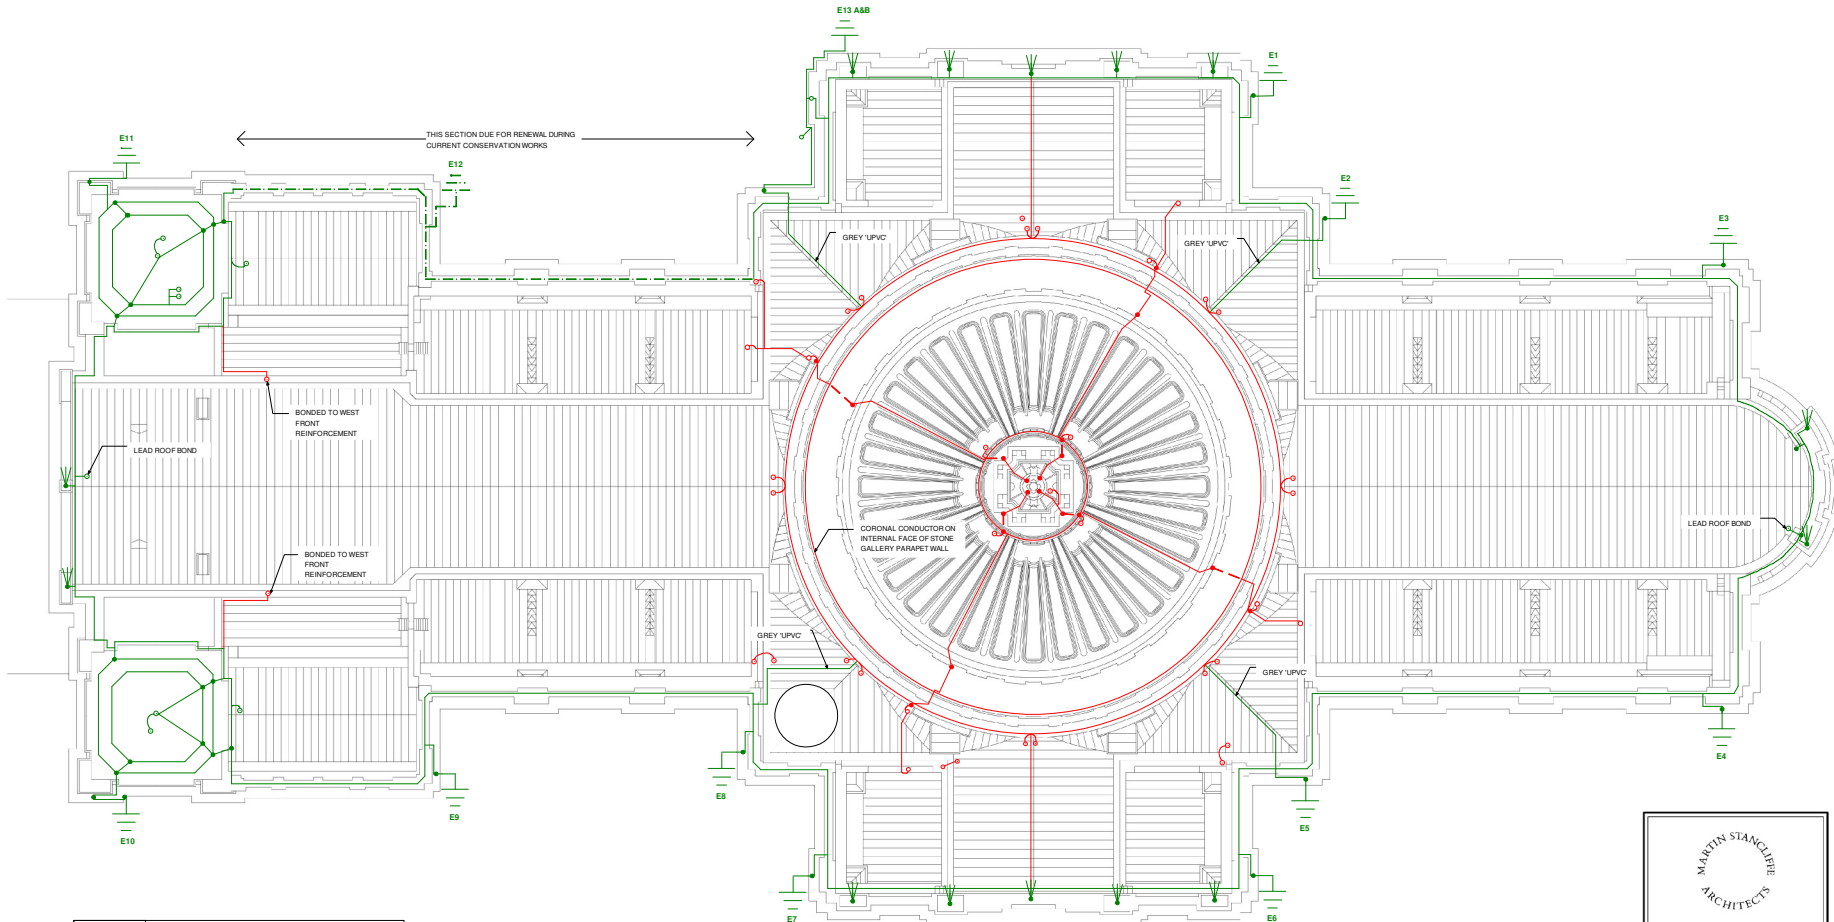
KEY	
	EXISTING LONG STANDING 1" X 1/8" CONDUCTOR TAPE
	BENEATH WALKWAY ASPHALT/DUCT
	DOWN CONDUCTOR
	INTERNAL BOND (UNKNOWN)
	METALWORK BOND (E.G. FIRE)
	TEST CLAMP AND EARTH TERMINATION
	RENEWED CONDUCTORS 8MM DIAMETER 'STONE' UPVC OR 25X3MM SOLID COPPER
	AIR TERMINAL FINAL
	METALWORK BOND
	CURRENT CONSERVATION WORKS AND RENEWAL IN PROGRESS
